DATE:	July 4 th , 2016
FROM:	Eric Lancaster
SUBJECT:	Weekly Progress Report @ Gold King
TO:	Kerry Guy

Project: Gold King Interim Water Treatment Plant (IWTP)

Reporting Period: June 27 – July 4

Report No.: 26

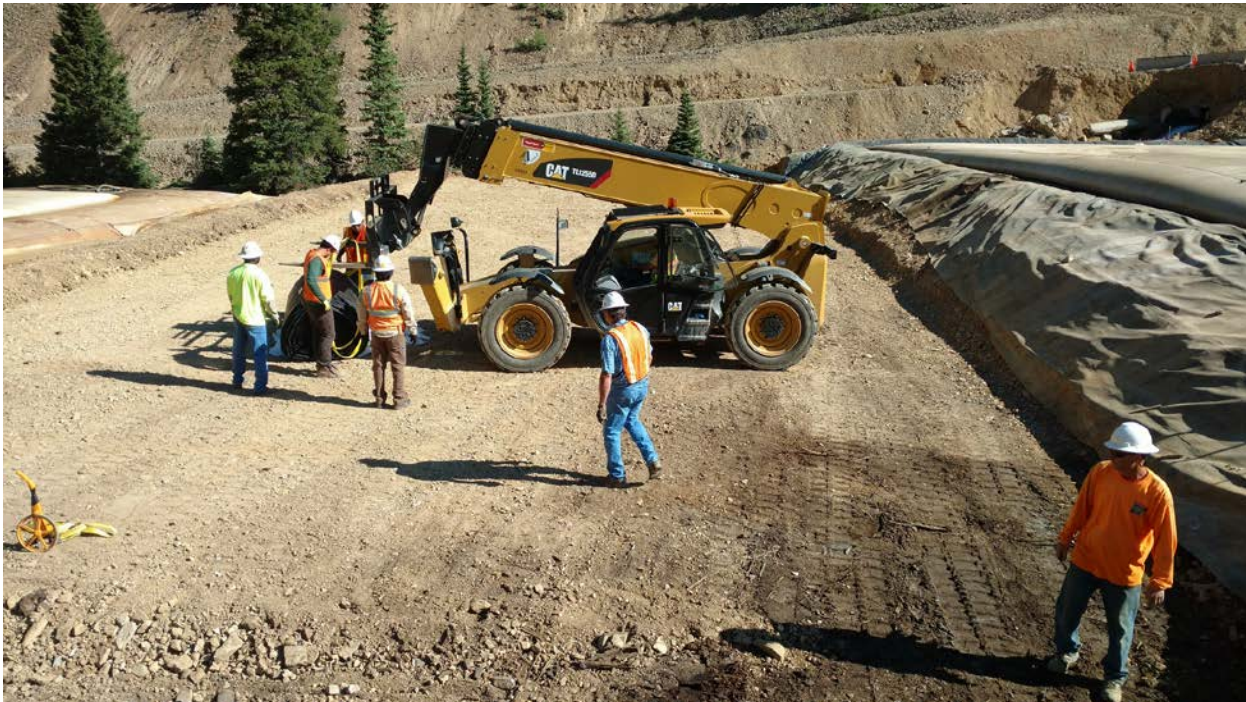
Photo 1: Lange Containment re-lining Cell B - Taken on 6/28/2016

- ER has removed all sludge from dewatering cells A and B. Cell A has been relined and additional bags have been placed and are back in operation.
- Lange Containment relined Line Cell B on Tuesday, June 28th.
- Summit Mechanical repaired the 12" HDPE discharge line on Tuesday, June 28th.
- Low pH water caused the butterfly valves at the inlet to the reactor tank to be eaten away. On Wednesday, June 22nd, the valves were replaced with 8" SS gate valves. At that time, a 1" thick build-up of sludge was found within the 8" HDPE pipeline that convey water from Pond II to the IWTP. Badger jetted the 8" HDPE pipes between the IWTP and Pond 2 on Wednesday, June 29th.

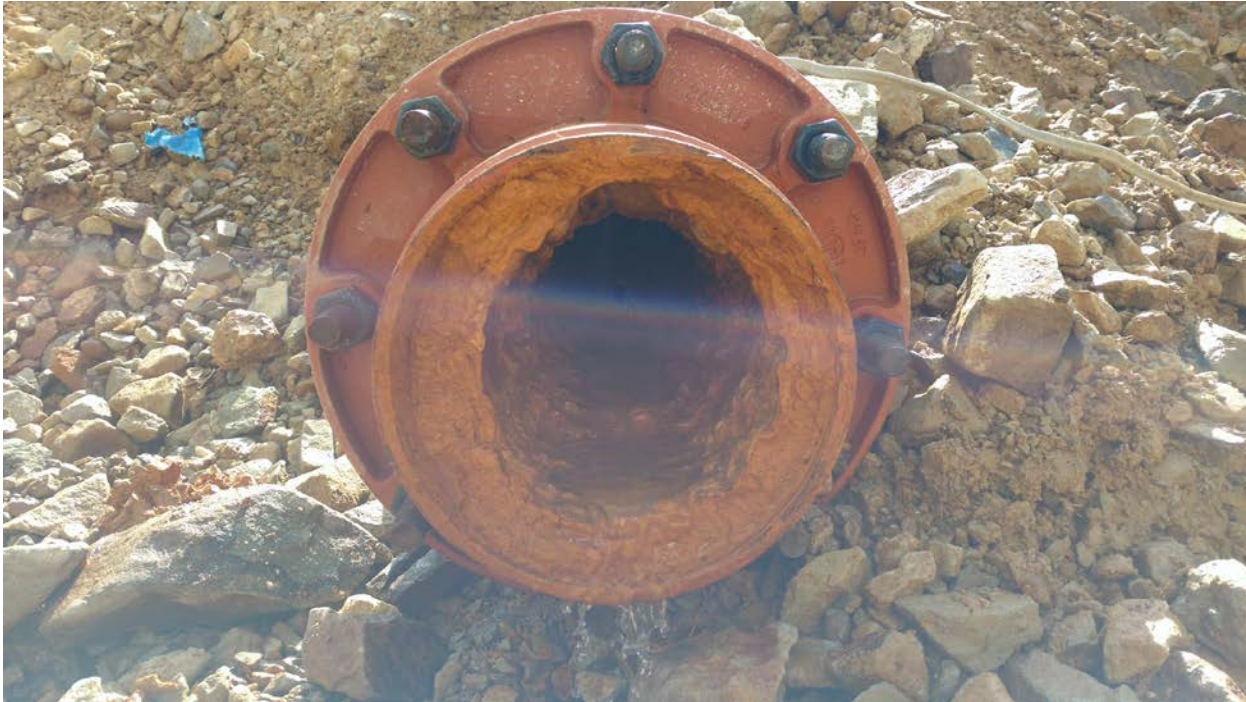
Photo 2: Build-up within the 8" HDPE pipeline – Taken on 6/29/2016

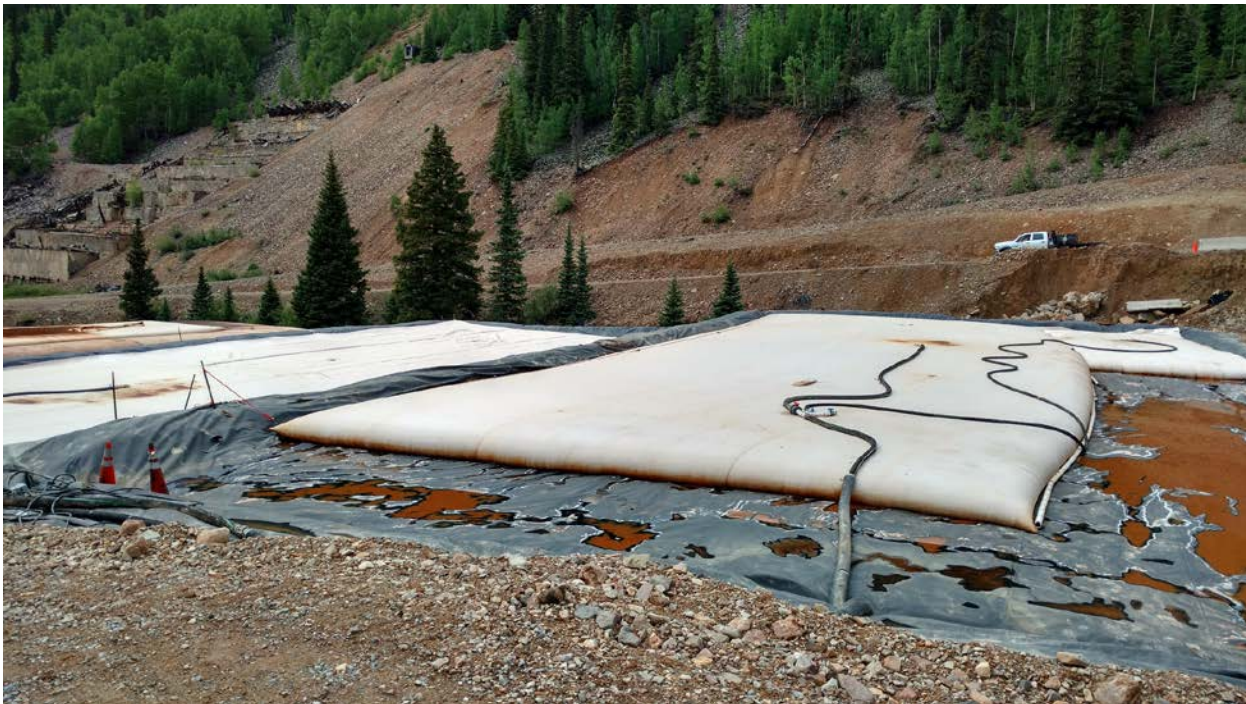
Photo 3: Bags in Cells A and B – Taken on 6/30/2016
